# Insight

## Stucco Woes: The Perfect Storm

By Joseph W. Lstiburek, Ph.D., P.Eng., Fellow ASHRAE

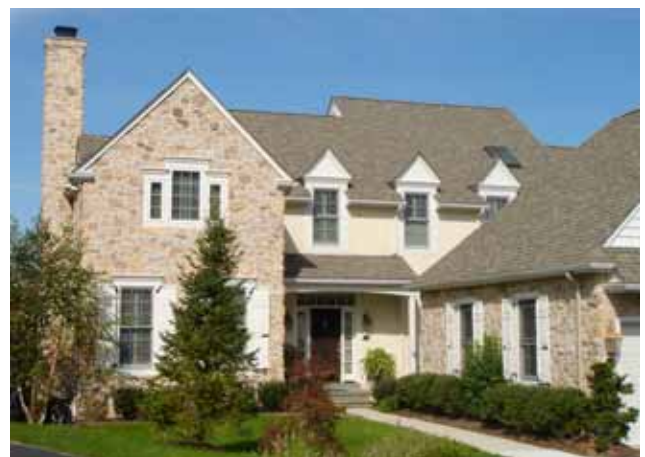
**Photograph 1: Pennsylvania Stucco “Shack”**—Eastern Pennsylvania is the stucco failure capital of the United States. Note the manufactured stone veneer—or “lumpy” stucco on the front façade.

We are seeing problems with stucco claddings in field of the wall—away from windows and “other architectural features.” And the buildings affected are not shacks (**Photograph 1**). And the problems are not limited to

Take away the plastic vapor barrier and I give you—eastern Pennsylvania—the stucco failure capital of the United States.

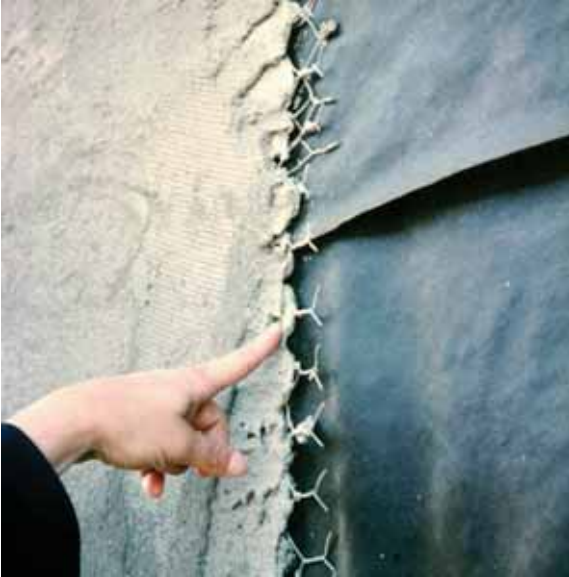
**Photograph 2: Hardcoat Stucco**—Three coats have been traditionally applied directly over a single layer of impregnated felt or asphalt saturated kraft paper. Today, this results in a bond between the stucco rendering and the outer layer of the felt or paper compromising drainage.

Hardcoat stucco is typically a three layer cementitious rendering (scratch coat, brown coat and top coat) applied over a building paper, metal lath and sheathing (**Photograph 2**). Manufactured stone veneer is a version of hardcoat stucco where the top coat is replaced with an embedded thin stone veneer (**Photograph 3**). Stucco claddings coupled with manufactured stone veneers are hugely popular because of their beauty—among other things. Unfortunately, the beauty is often only skin deep, as they are also commonly linked with moisture problems (**Photograph 4**). This was not always the case and the reasons for the change in performance are due to several seemingly small factors that add up to a huge factor:

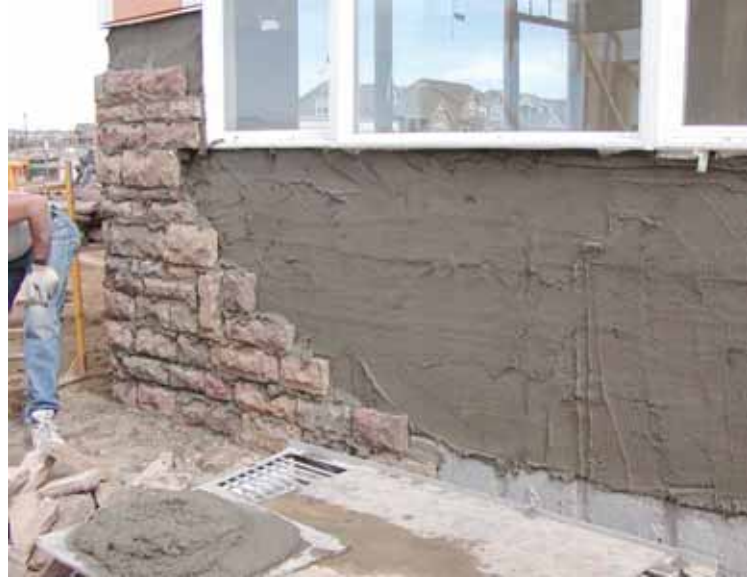
**Photograph 3: Manufactured Stone Veneer**—Manufactured stone veneer claddings are very similar to hardcoat stucco and perform in a similar manner. In a manufactured stone veneer the outer coat of stucco is replaced with a thin stone layer.

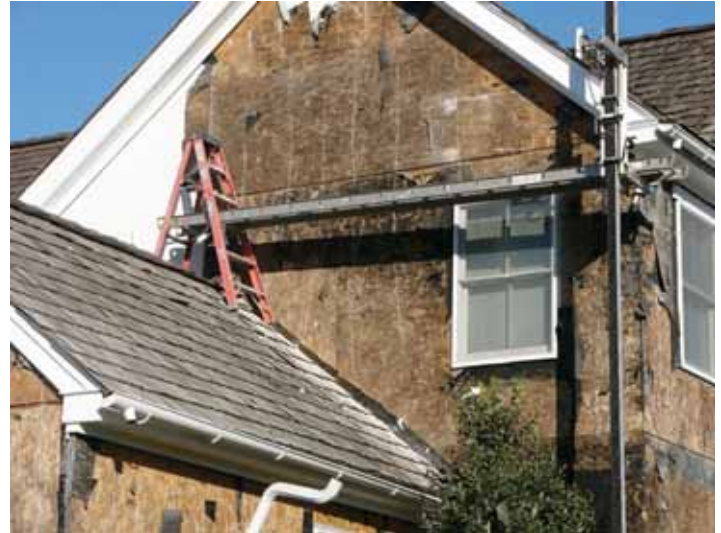
**Photograph 4: Hardcoat Stucco Failures**—Note that the damage is in the field of the wall away from windows.

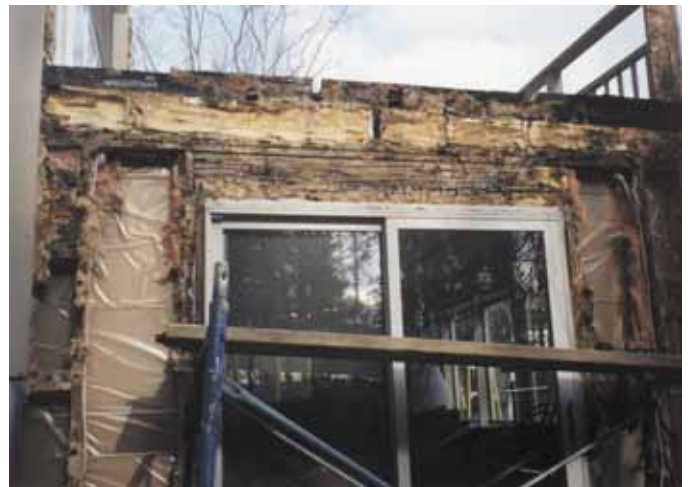
**Photograph 5: Failure on Steroids**—Note the plastic vapor barrier “accelerant” in this Vancouver, Canada building.

assemblies. In many cases even two of these changes combined do not lead to grief. But three, any three, and problems begin to raise their heads. And with four or all five, it gets ugly, very ugly—we call this type of ugly—Vancouver ugly (**Photograph 5**). Let's look at each of these small factors individually at first.

Now, to the plastic vapor barrier thing. What can I say that I haven't said about this earlier. The interior plastic vapor barrier prevents inward drying during cooling periods. Except in extreme heating climates plastic vapor barriers are unnecessary. The reduction of inward drying is often enough to push the wall over the edge if it is borderline to begin with (go back and look at **Photograph 5**).

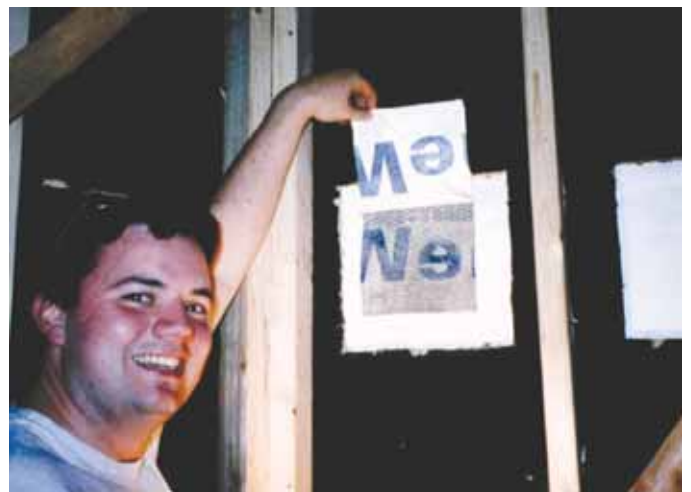
**Photograph 6: Hardcoat Stucco Bonding to Plastic Building Paper**—A young, happy engineer, discovers that stucco does indeed bond to plastic building papers preventing drainage. The engineer is my friend Chris Schumacher—may he remain this happy when he gets older.

Building paper manufacturing changes and the introduction of plastic building papers (also referred to as “building wraps” or “housewraps”) led to a change in the water management attributes of stucco renderings installed directly over these materials. Older building papers were more “robust” than more recently manufactured products—they weighed more and had more cellulose content. As a result when stuccos were applied directly over them a bond between the stucco and the building paper did not develop due to the dimensional instability of the cellulose. The absence of a bond permitted a modest degree of drainage to occur between the building paper and the stucco. With more recently manufactured building papers a bond develops between the building paper and the stucco—preventing drainage between the building paper and the stucco. The bond between plastic building papers and stucco is even greater (**Photograph 6**).

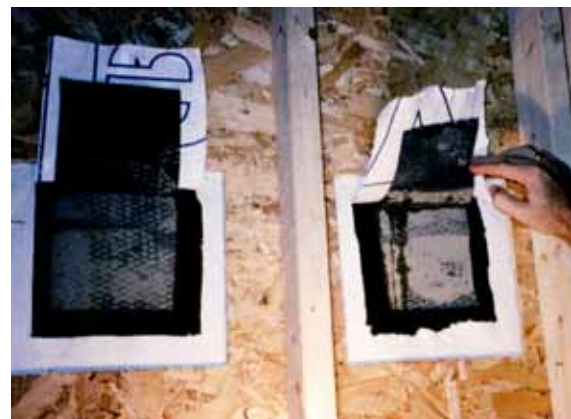
**Photograph 7: Building Paper Bond Break**—Traditional building paper is an excellent bond break between traditional hardcoat stucco and plastic building papers.

The solution to the bonding problem is pretty straightforward—the use of a “bond break”—an additional layer of building paper between the stucco and the water management layer building paper (two layers of building paper). The best bond break between building paper and stucco, is, you guessed it, another layer of building paper (Figure 1). Similarly, a building paper bond break should be used between plastic building papers and stucco. For reasons that are not quite understood<sup>3</sup> plastic building papers do not make as good a bond break as paper building papers (**Photograph 7**). The use of a second layer of building paper as a bond break is not ubiquitous—it should be. Stucco, today, needs every edge it can get.

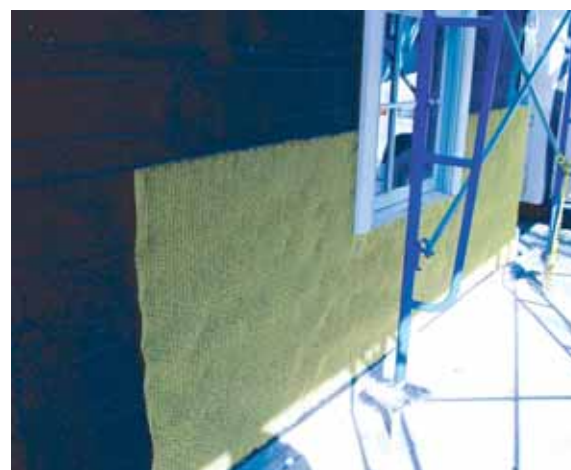
**Photograph 8: Air Gap**—The air gap does not have to be particularly big to be a big deal—3/8 inch (9 mm). One method of getting the air gap is to use a drainage mat between two layers of building paper. The gap allows redistribution of the moisture in both the stucco and the OSB sheathing.

The air gap does not have to be particularly big to be a big deal—3/8 inch (9 mm). One method of getting the air gap is to use a drainage mat between two layers of building paper (**Photograph 8**). The gap allows redistribution of the moisture in both the stucco and the OSB sheathing. The gap also does something else—if it is wide enough it becomes a ventilated space making the “Goldilocks” vapor curve argument moot. Once we have a ventilated space (with meaningful air movement) the permeability of the traditional building papers and plastic building papers almost does not matter. Anything between the “low perm” and “high perm” materials can be shown to work. In fact, an insulated semi-permeable sheathing does the best job of controlling inward vapor drives in all climate zones.
